**Upper Tuolumne River Ecosystem Project:
Streambank Stability Study in Poopenaut Valley,
Yosemite National Park, California**

Technical Memorandum - Final

Prepared by
Stillwater Sciences
2855 Telegraph Ave., Suite 400
Berkeley, CA, 94705

February 2011

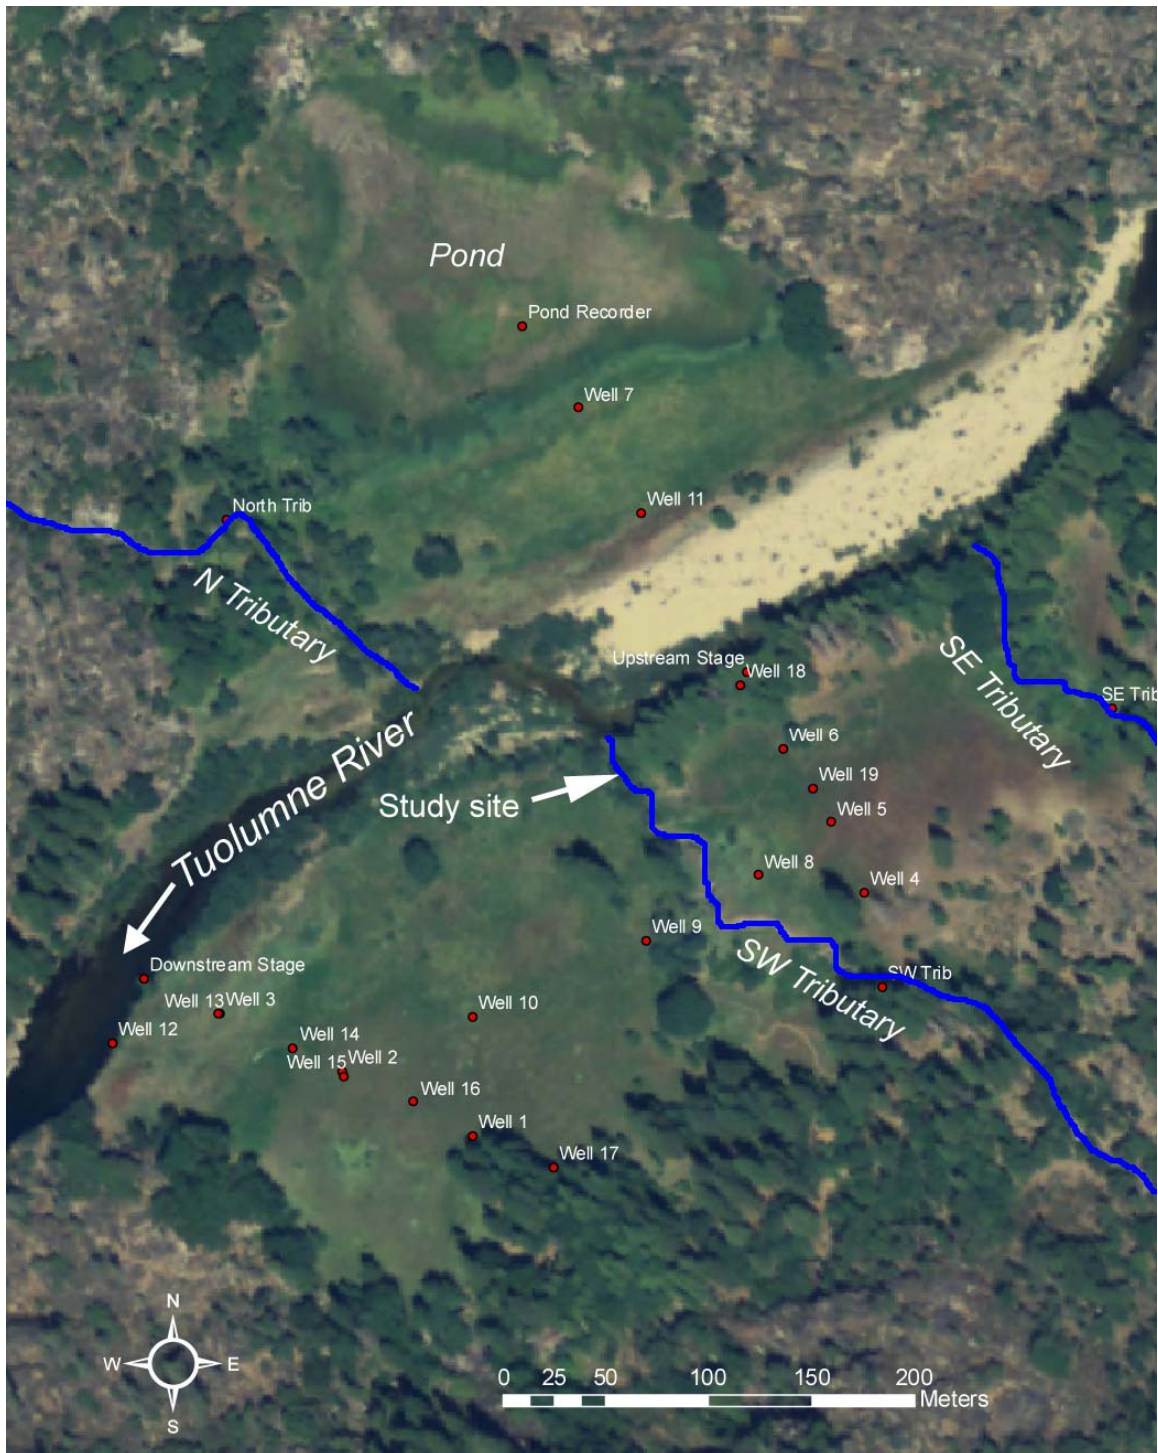
Figure 2. Locations of the study site, valley tributaries (shown as blue lines), and NPS piezometer wells (shown as red points) in Poopenaut Valley (after Stock et al. 2007). Stage recorders are also shown and designated as follows: Tuolumne River = “Upstream Stage” and “Downstream Stage”; Southwest Tributary = “SW Trib”; Southeast Tributary = “SE Trib”; and North Tributary = “North Trib”.

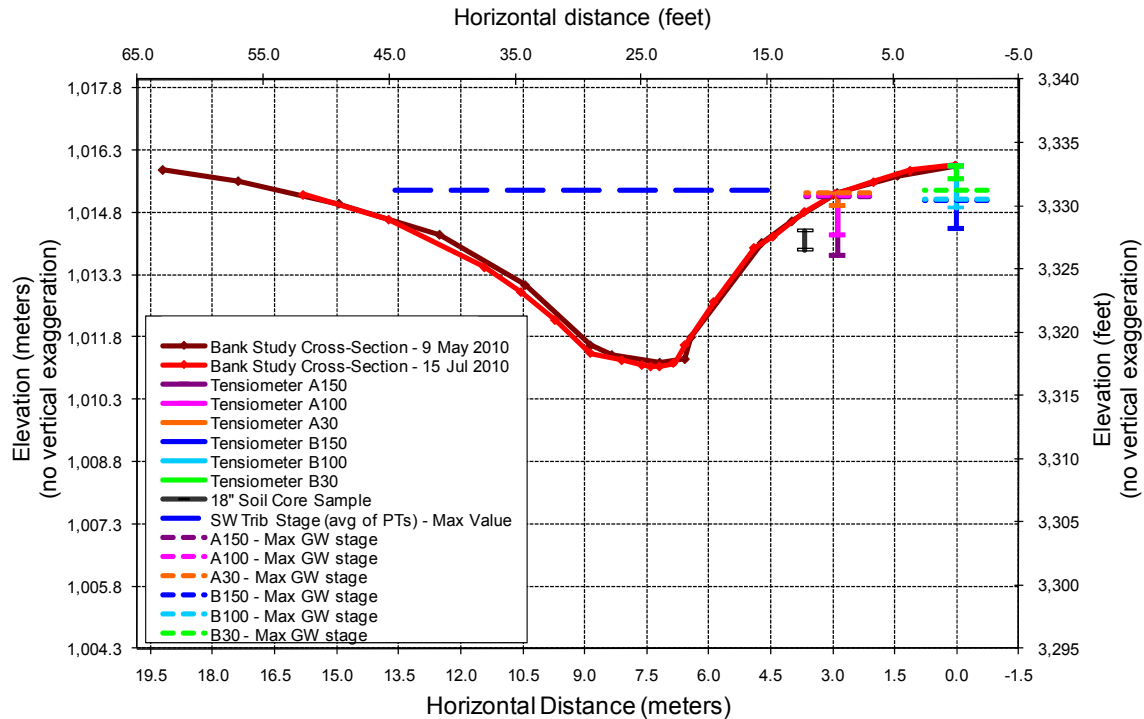
Figure 5. Comparison of channel cross-sections at the bank stability site representing pre- and post-study conditions (view looking downstream). The comparison reveals that no changes in the cross-section profile occurred during the Spring 2010 high-flow releases. The small deviation visible between the two cross-sections is due to normal survey variability due to differences in specific rod placement between the two surveys. The locations of the six tensiometers and the soil core sample are also shown for reference. The maximum flood stage and groundwater level in the stream channel are also shown (dashed blue line).

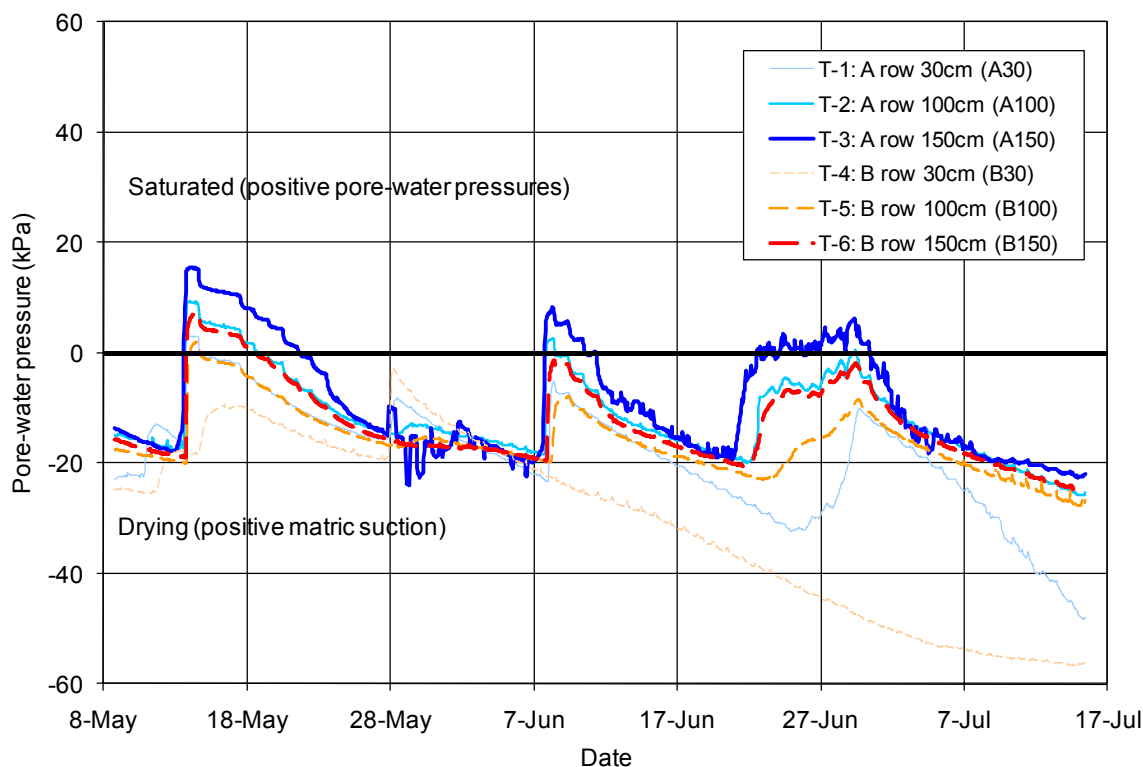
Figure 7. Measured pore-water pressures at the six tensiometers installed in the top of the right bank of the Southwest Tributary at the bank stability study site. Values greater than zero indicate saturated conditions during valley inundation, while values less than zero indicate drying (i.e., positive matric suction) conditions during drawdown. The deeper tensiometers experienced the greatest pore-water pressures.

The six tensiometers successfully recorded pore-water pressures at their respective locations and depths in the right bank of the study site throughout the flow releases (Figure 7). Trends in these data reflect periods of saturation and drying as the water table rose and fell in accord with the flooding of the valley. The deeper portions of the bank experienced greater pore-water pressures, while the shallower portions experienced lower pore-water pressures for a given moment in time. However, one exception to this trend was during late May when rainfall partially saturated the shallow depths of the bank top, momentarily causing the shallower tensiometers to record relatively higher pore-water pressures than was recorded by the deeper tensiometers.

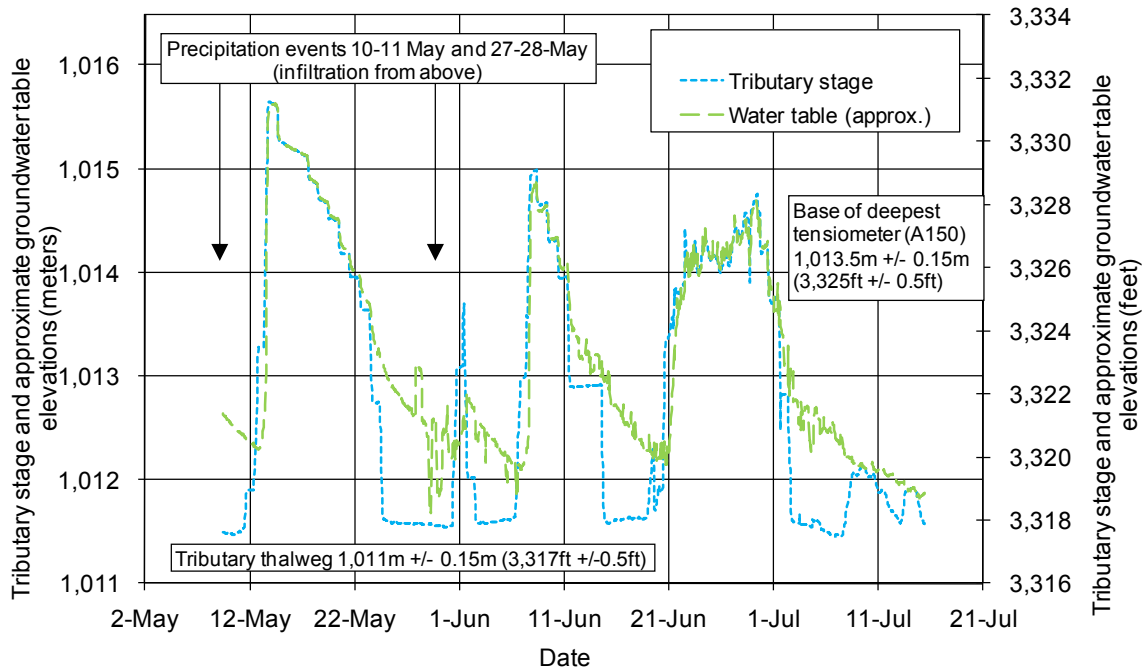
Figure 8. Plot of the recorded tributary stage and approximate water table elevations at the bank-stability study site during the Spring 2010 high-flow releases. As shown, the estimated water table generally kept pace with the changing water-surface elevations in the stream channel during the rising and recession periods of the flood peaks when above 1,013.5 m (3,325 ft). Below this elevation, the estimated water table deviates from the falling tributary stage giving the appearance that groundwater drained at relatively slower rates when positioned within the lower half of the bank profile.

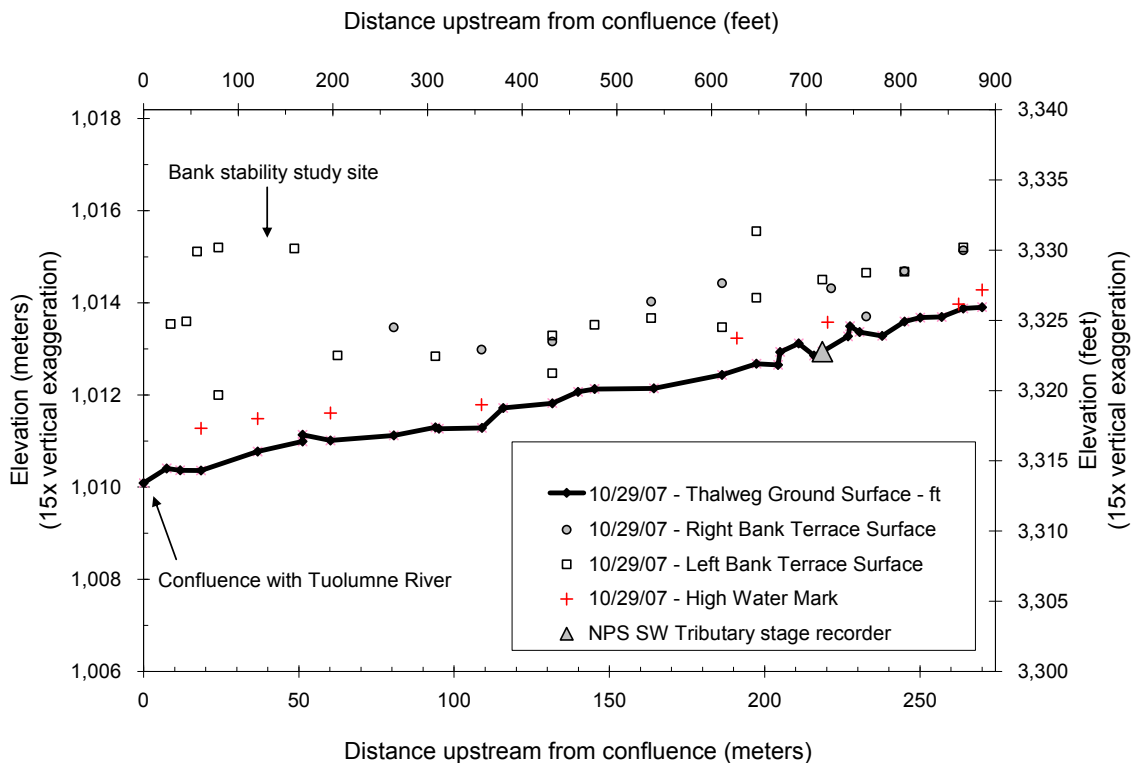
Figure 9. Longitudinal profile of the Southwest Tributary showing the bank stability study site, the NPS stage recorder locations, the elevations of the right and left bank terraces, and the high water marks as observed by the surveyors (29 October 2007) based on geomorphic indicators.

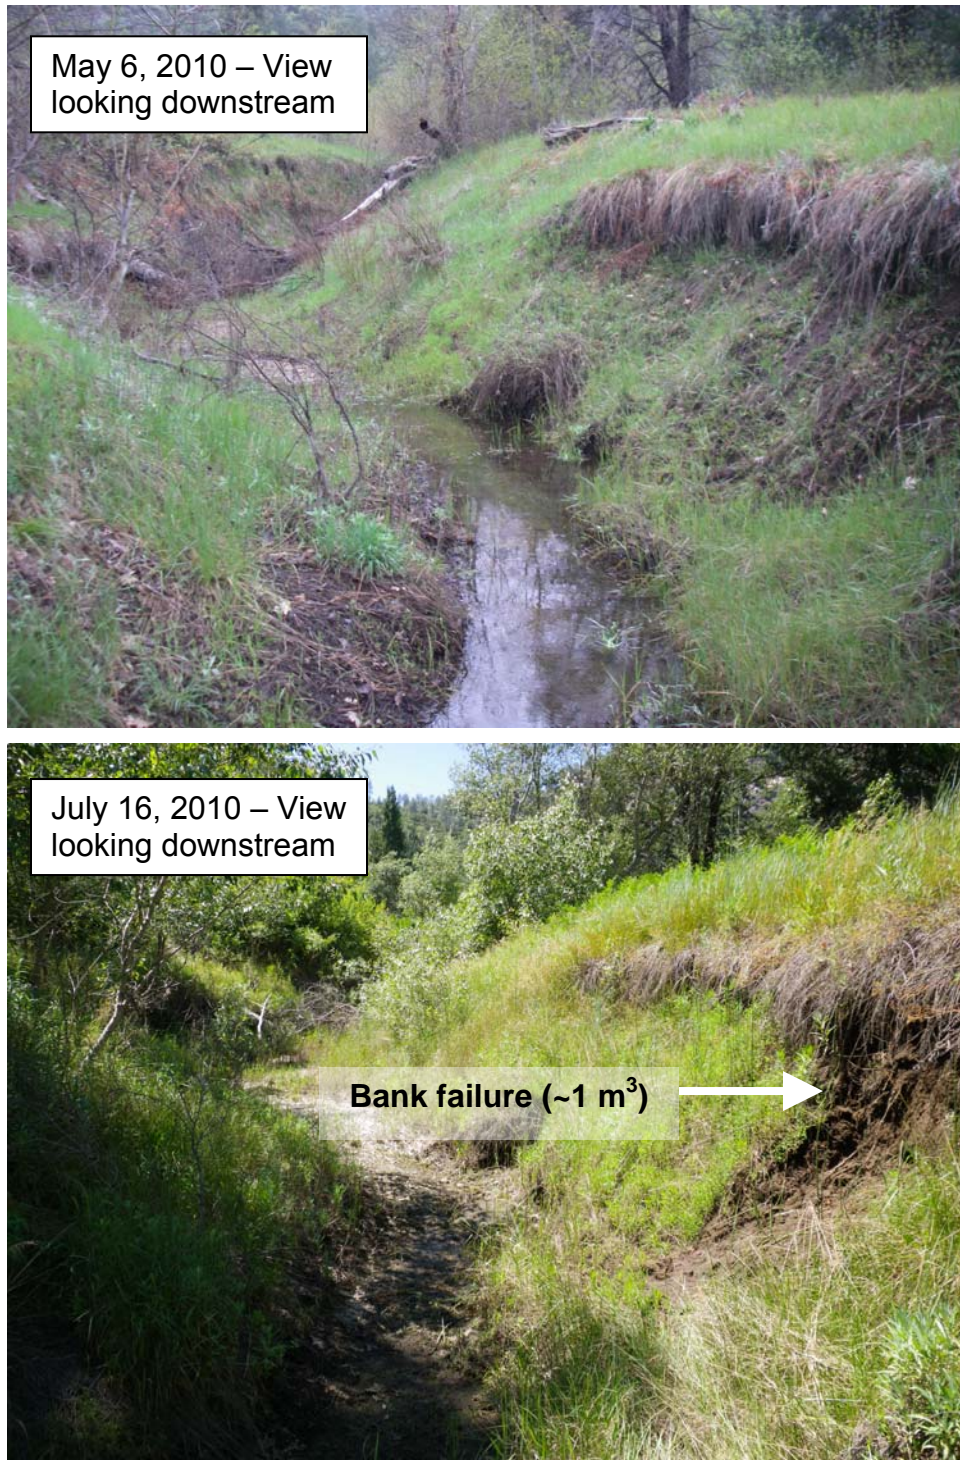
Figure 11. Photos taken along the Southwest Tributary approximately 30 m upstream from the study site showing a before and after view of the channel where the only occurrence of bank failure was noted along the entire channel length.

The Southwest Tributary is characterized by a moderately sinuous, low-gradient alluvial channel with fine sandy loam banks and a sandy gravel bed. Although sampling of the bed materials for analysis for their size distribution was not conducted, the median grain size (D_{50}) was visually estimated to be approximately 4 mm in diameter, but patches of coarser particles were noted throughout. The channel exhibits a subtle bar-pool morphology that transitions to a more plane-bedded, incised channel closer to the confluence with the river. The thalweg gradient along the lowermost 275 m of the channel, as surveyed in 2007 by NPS staff, is approximately 1% (Figure 10). The degree of channel incision increases with downstream distance, particularly as the channel cuts through a natural levee deposited upon the river’s left bank (see the small square and circle symbols in Figure 10 representing the elevation of the top of the left and right banks). The tributary channel is incised, with steep banks reaching up to 4 m above the channel bed (Figure 5). The bank profile is convex, rather than being vertical with a well-defined edge at the top of the bank. Vegetation coverage also increases with downstream distance, supporting riparian species such as willows, cottonwoods, incense cedars, and black oaks that grow on the floodplain and bank surfaces. Throughout the valley and in the channels, there is a dense herbaceous coverage which likely provides yet another level of protection to the streambanks, by shielding the banks from excess shear stresses during high tributary flows and by providing additional cohesion to the bank materials (Figure 11).

Overall, there was a single observed occurrence of bank failure along the entire ~250 m length of the Southwest Tributary during the study period (Figure 11). This single failure represents approximately 0.25% of the total linear distance of both banks combined. The failure is characterized as a rotational slide of a relatively small mass (~1 m³) that occurred after the formation of a failure plane in the subsurface of the bank. This mass fell directly upon the bank toe and appeared to retain most of its original volume. No failure occurred at the study site based on field observations and on repeat surveys of the channel's cross-section (Figures 5 and 12). Further inspection of the banks did not reveal any signs indicative of bank failure, such as tension cracks or groundwater seepage (piping). Herbaceous and shrub vegetation coverage on the floodplain, banks, and even on the channel bed increased considerably during the study period, which is likely a normal phenomena in late spring as vegetation growth is induced by seasonal factors rather than by any influences from the high-flow releases implemented this year. In the other two valley tributaries, observations made by NPS staff during and following the high flow releases did not note any apparent occurrences of bank failure (J. Roche, pers. comm., 2010).

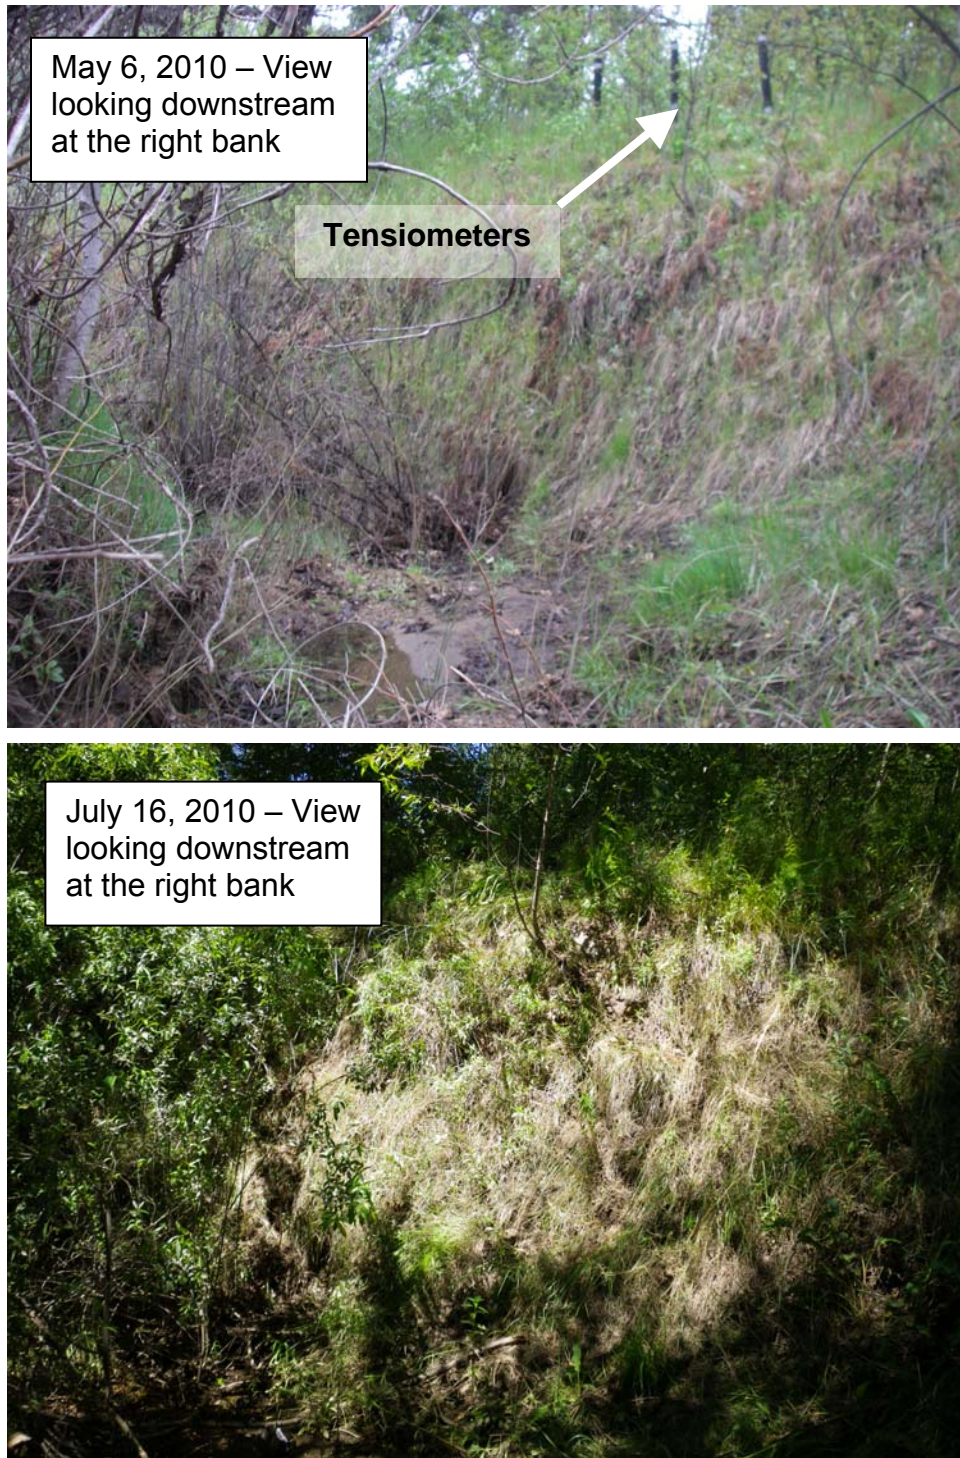
Figure 12. Photos taken of the bank stability study site on the Southwest Tributary before and after the high-flow releases. Note the absence of bank failure and the increase in herbaceous vegetation coverage on the bank surface.

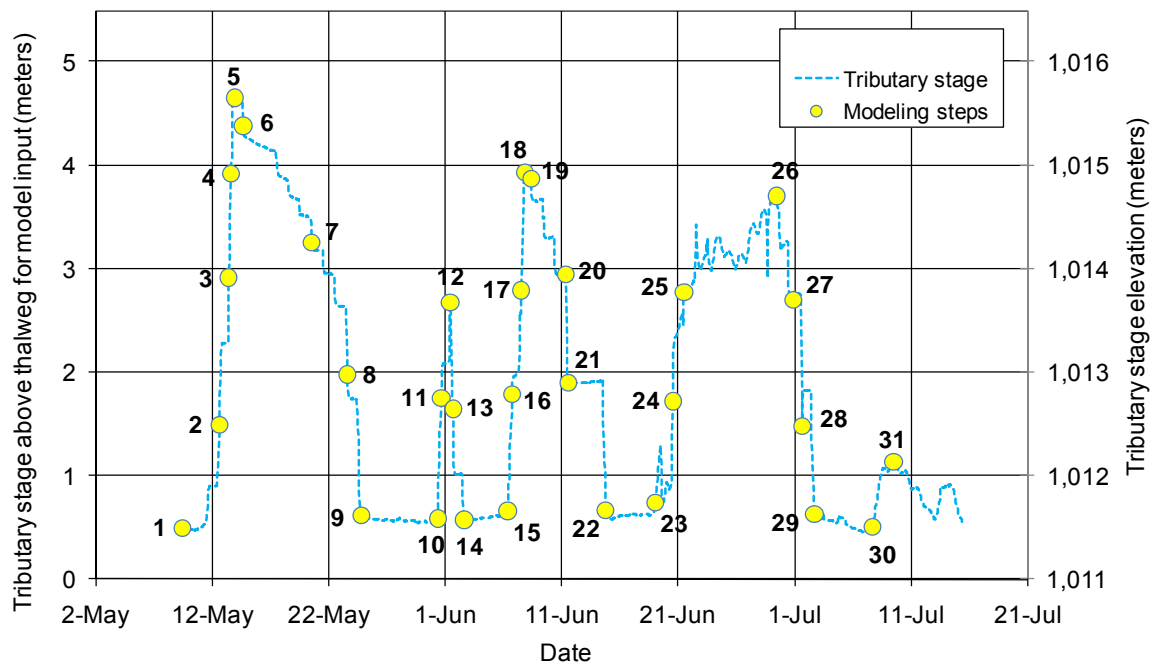
Figure 13. Plot showing the differentiation of the tributary stage into 31 steps for use in modeling Scenarios 1A and 1B. The primary y-axis (left side) represents the tributary stage above the thalweg, which, per the requirements of the BSTEM model, is set to an elevation of zero. The secondary y-axis (right side) represents the real elevations. Steps, or computational nodes, evaluated with the model are numbered and their points are shown in yellow.

Incorporating the continuously recorded data from the two-month-long study into BSTEM was infeasible due to the sheer volume of data collected (over 1,600 pairs of data). To better manage this large dataset yet still effectively model the stability conditions during the study period, we differentiated the flood hydrographs into 31 steps, where a step was assigned when there was a 1-m change in tributary stage or the stage reversed direction, such as at a flood peak. Thus, periods of the flow releases having dramatic changes (e.g., period of inundation) had several close-together steps, while periods having minimal changes (e.g., low flow between the inundation peaks) had relatively few steps (Figure 13). The location of the steps, or nodes as shown in Figure 13, ultimately makes no difference on the model’s computations because the model is simply evaluating the conditions present at that particular moment in time and has no consideration of conditions that occurred prior to or following that moment. That is, all nodes evaluated by the model are computational locations that together capture the range of head differentials that occurred over the hydrographs and that changing the node locations or their spacing would not change the computational results.

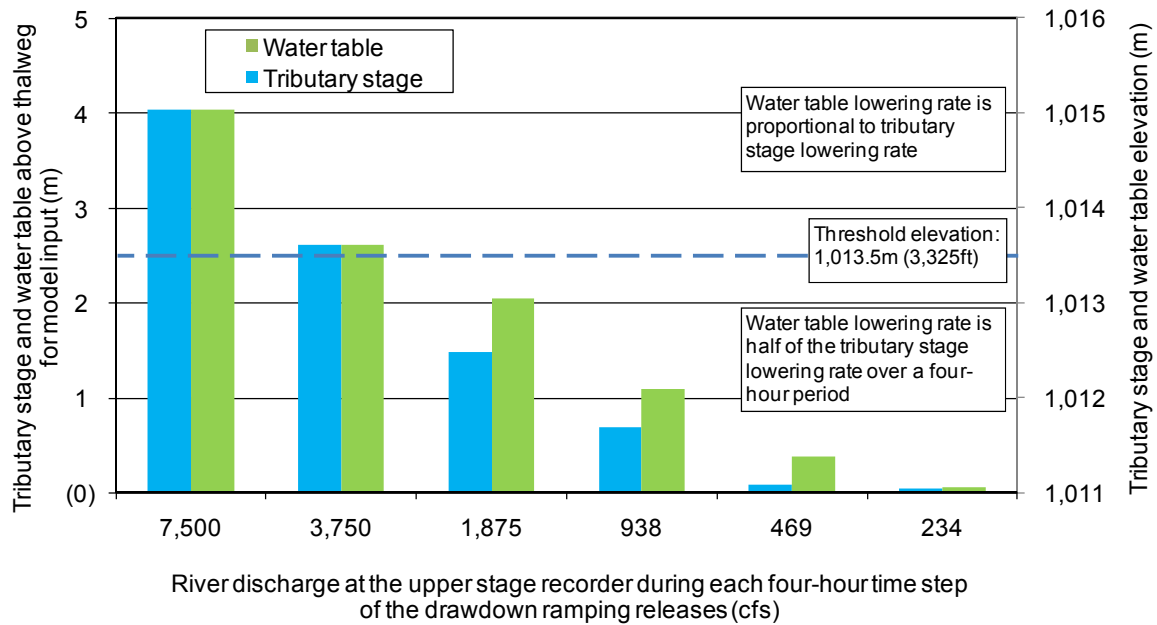
Figure 14. Plot of the tributary stage and estimated water table elevations during drawdown ramping rates as evaluated under Scenarios 3A and 3B. The ramping rates consisted of a 50% reduction of river flow every four hours.

The final scenarios evaluated with BSTEM entailed calculating the F_s at various steps of drawdown ramping rates implemented in previous years. Prior to 2010, the dam-controlled high-flow releases in spring consisted of relatively faster drawdown ramping rates that generally followed a reduction in river flow by 50% over 4 hours. In this scenario, we co-varied the water table with the falling tributary stage, starting from the bank top. The rate at which the water table lowered with the tributary stage was based on the hydraulic properties of the bank materials. As discussed above, the water table was found to lower in sync with the falling tributary stage when above the threshold elevation of approximately 1,013.5 m. Below this threshold elevation, the water table was found to lower at a reduced rate, which we estimated to be half of the tributary stage lowering rate based on a review of the NPS’ well and stage recorder data (Figure 14).
