2020 Tuolumne River Basin Hydrologic Conditions

Water Year 2019

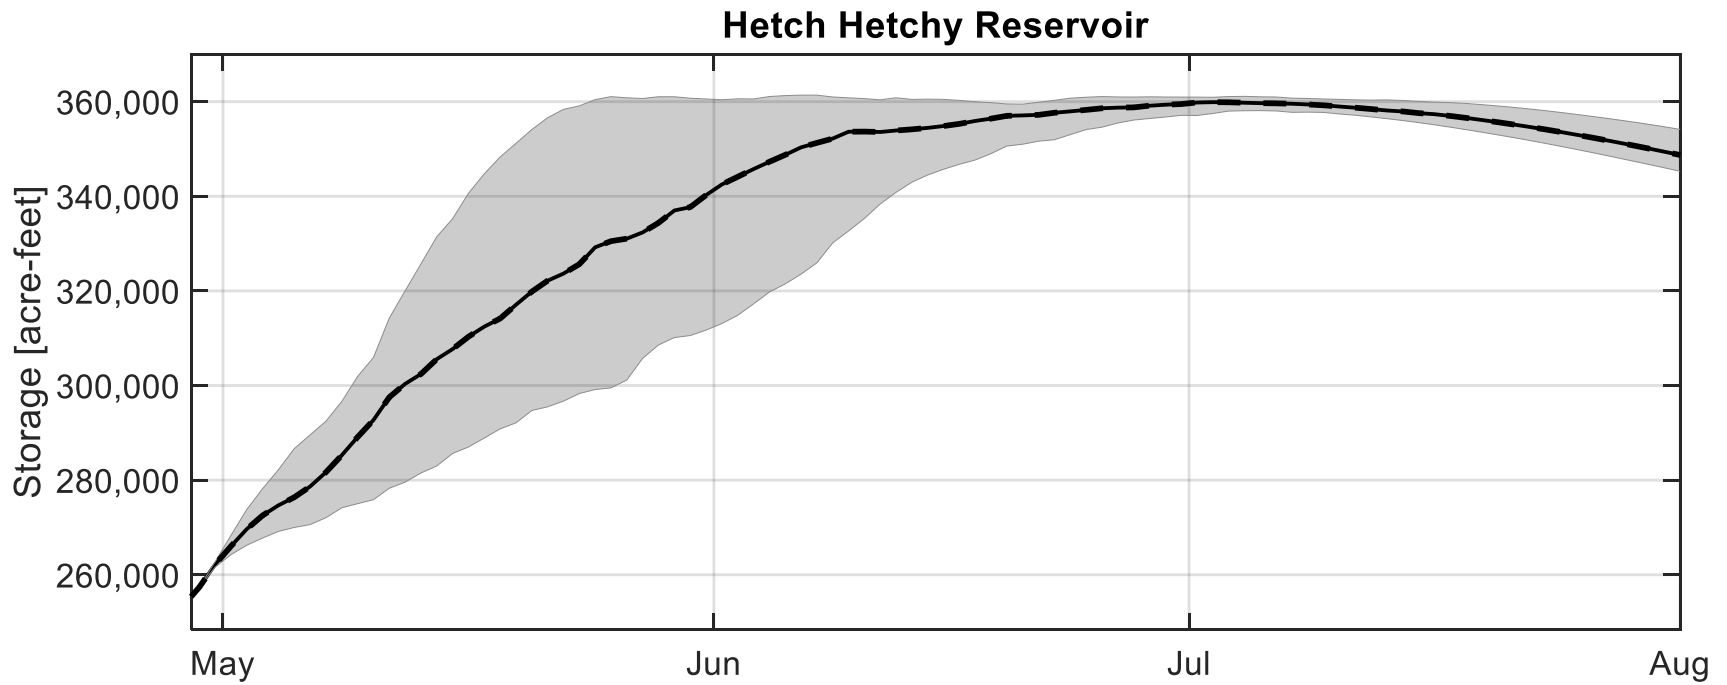
Hetch Hetchy Refill Outlook

- Sufficient to refill Hetch Hetchy Reservoir, Cherry Lake and Lake Eleanor
- Insufficient to refill Water Bank
- Water available for generation
- Small or no Hetch Hetchy Reservoir Spill
 - 0 TAF to 70 TAF
